## Adjustment of the pusher cylinder support

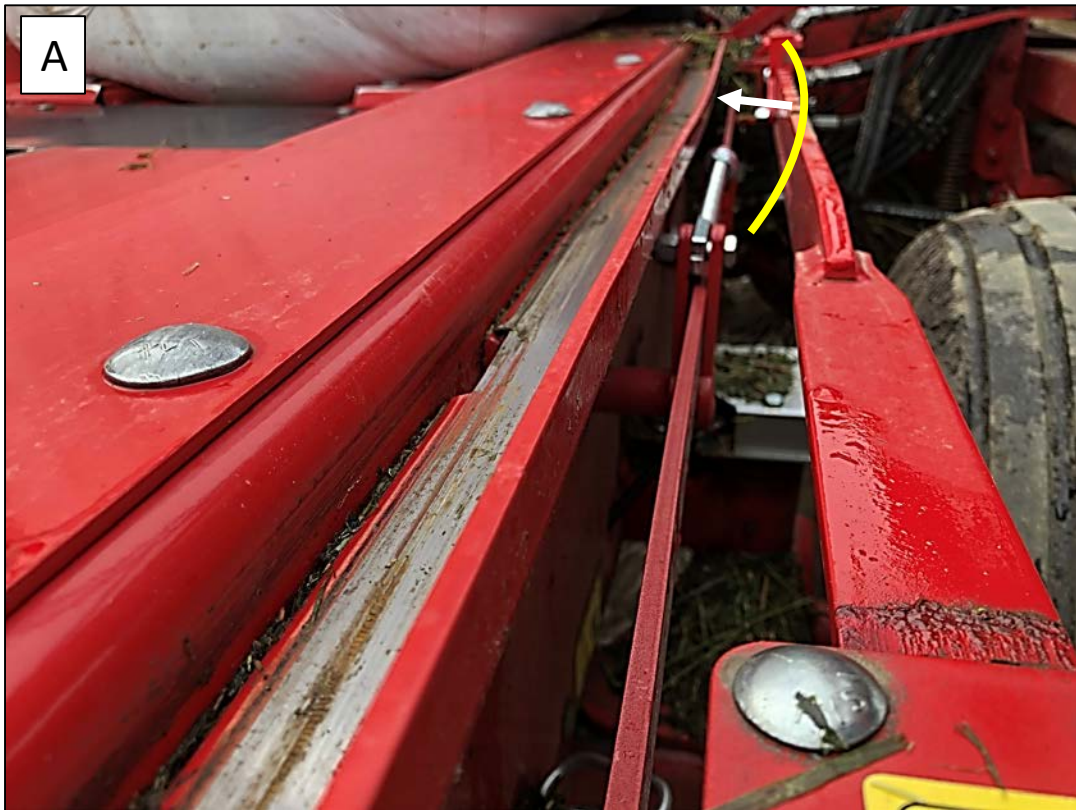
If the rail where the teflon guide goes is bent as the picture A, that significate that the pusher cylinders supports are badly adjusted.

1. Start up the engine and activate the pusher in order to move forward at its maximum stroke (before coming back), then push on the emergency start & stop button and shut off the engine.
2. For the next steps, you may remove the fenders with a 9/16 socket but is optional because it is possible to reach the adjustment bolts without to remove them.
