## PROCEDURE REF# A-IND-049

## Second arm lock valve kit on a 780SB

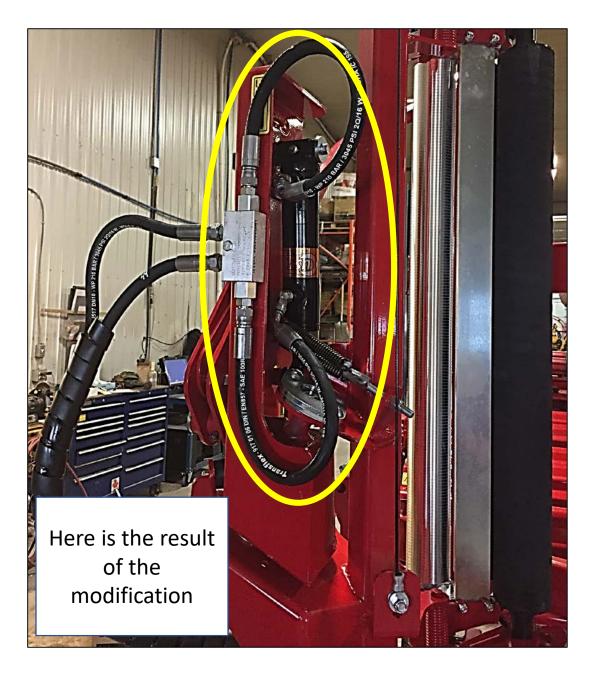
If the 2nd stretcher folding arm goes down when out of service, the installation of that kit will solve the problem.

The part # is 224234-1.

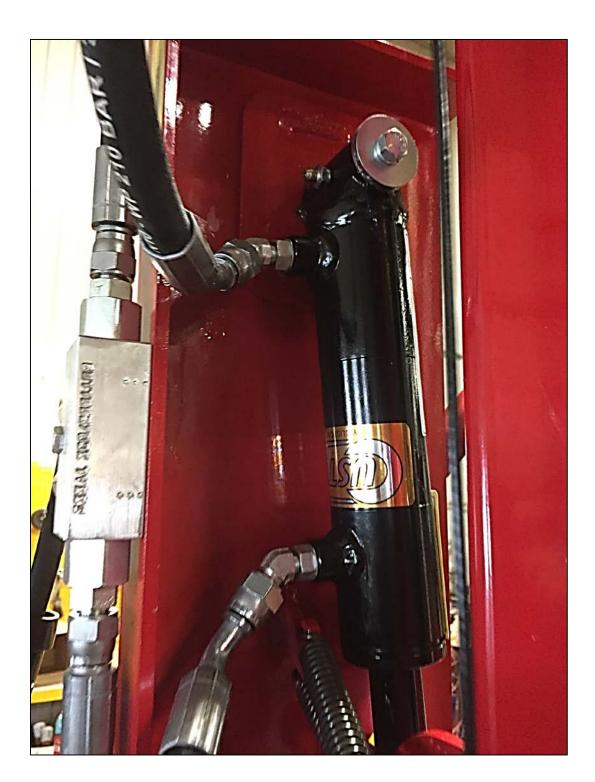
Installation on the cylinder.

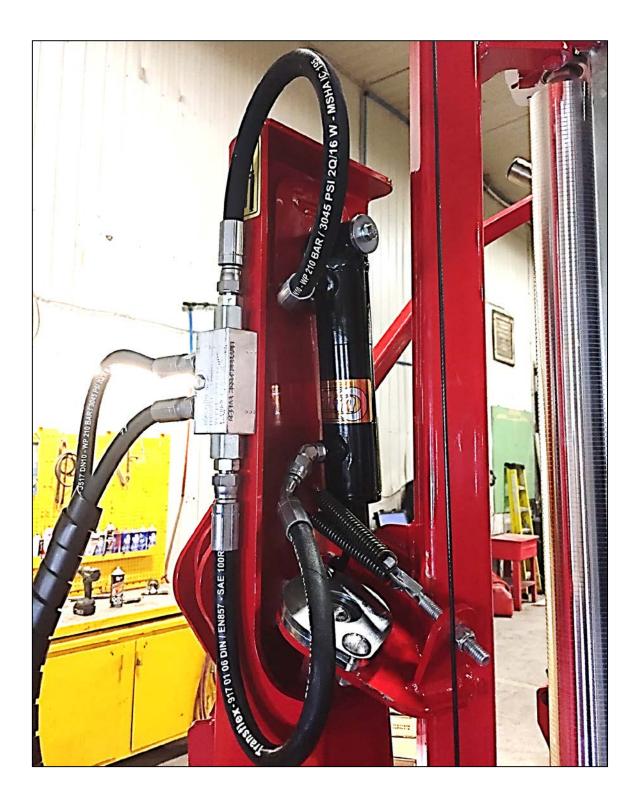
Here is the installation of the lock valve.
