### Error #8

### Short-circuit in the left conveyor/pickup unit

#### MC024 – C2P03 - Function

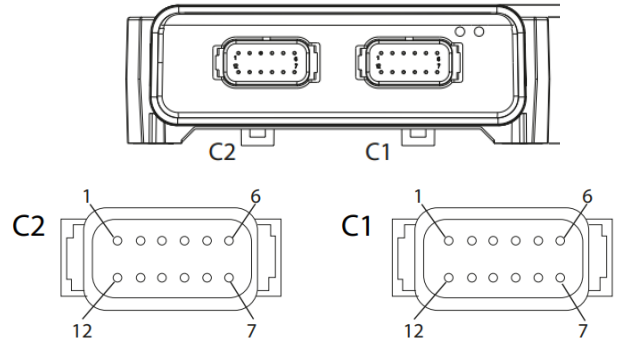
Identification of the controller in problem

Identification of the PIN # on the controller where the wire start from

Identification of the sensor or coil's valve section where the wire go to

Error #8 means that there is a short-circuit between the controller and the solenoid valves of the "left conveyor".

Inspect the wire from pin #03 of the MC024 controller's C2 connector until solenoid valve "left conveyor" located as below illustration. If the wire is damaged, replace or fix it.
