Erreur #34

The error #34 means that the oil tank level is too low.

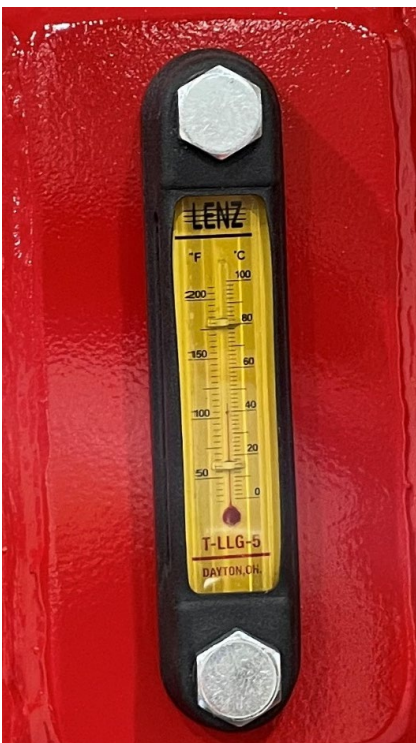
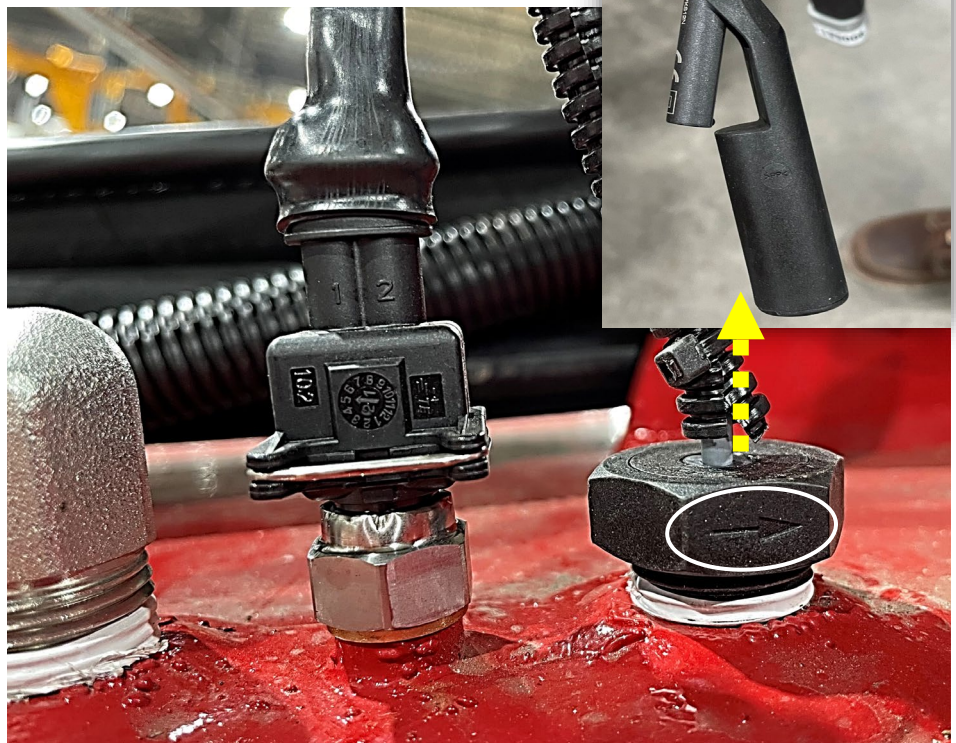
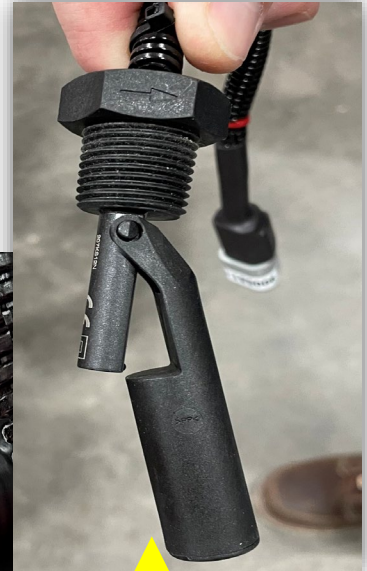
1. Verify the oil gauge located on the side frame (left picture). It must be completely soaked in oil. Add hydraulic TDH oil if needed. If the level is accurate, pass to the next step.
2. Inspect the harness that goes to the oil level sensor to make sure it is not cut or pinched. Repair or replace the cable (#315370) if needed.
3. If the harness is not damaged, replaced the oil level sensor.

Note: The arrow on the sensor (above the oil tank) must point backward the machine to ensure its proper functioning.
