## PROCEDURE REF# A-INL-010

## 1- Check if the wiring has not been modified (inversed wires).

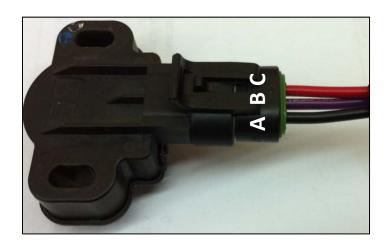
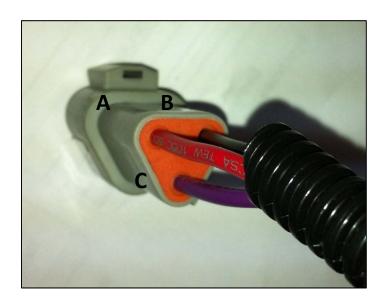
- As the picture, face to the wheel angle sensor, the red wire is at right(C), the purple wire is at the center (B) and the black one is at the left (A).
- At the end of the harness, these 3 wires are in a triangle connector. Like in the picture beside, the side with the locking bracket (upwards), the black wire goes to the right, the red wire goes to the left and the purple one goes downwards.
- Note that this triangle connector is plugged with another triangle connector and the wires colors are the same.
