Verification of the Rotary table gears

In order to verify if there is excessive wear between the hydraulic motor gear and the rotary table gear due to a lack of grease, follow the next steps.

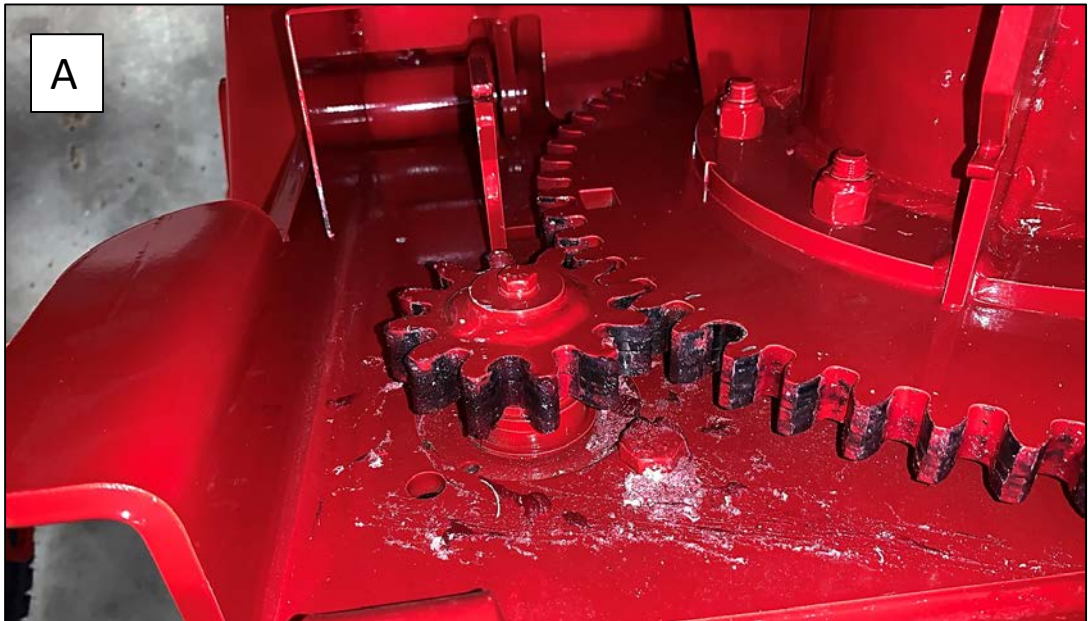
- With a socket or wrench 7/16, unscrew the 2 bolts of the front cover (towards the front of the wrapper), then pull off quite strongly towards the front (A);
- Make sure that the 2 gears fit together as illustrated on the picture B. Replace if needed;
- Grease the gears then reinstall the cover by tacking care it is well installed under the rear cover.
