Error #5

Sensor error HYD_PRES

MC024 – C1P05 - Function

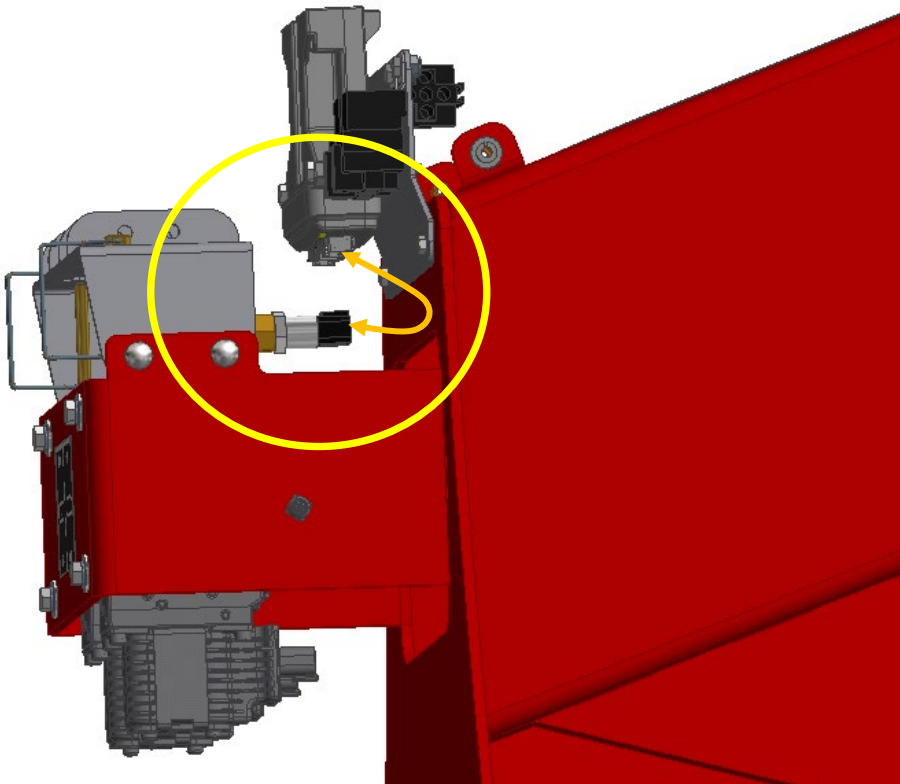
Inspect the wire from pin #05 of the MC024 controller's C1 connector until the hydraulic pressure sensor located as below illustration. If the wire is not damaged, the hydraulic pressure sensor must be replaced. In the Settings menu, click on tab INPUTS/OUTPUTS and the C1-P05 (System pressure) will indicate 0 mV when in error.

Error #5 means that the controller does not receive signal from the hydraulic pressure sensor while the PTO is turning.
