Error #10

Short-circuit on the right conveyor/pickup unit

MC024 – C2P04 - Function

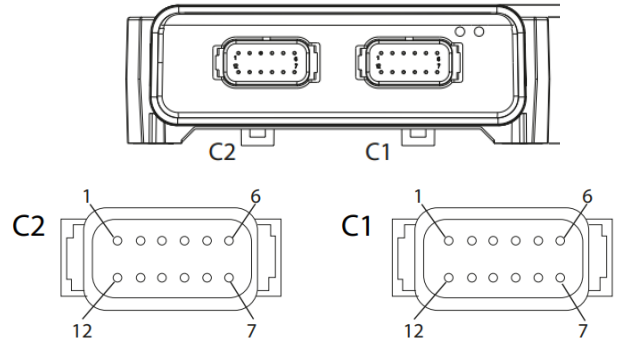
Identification of the controller in problem

Identification of the PIN # on the controller where the wire start from

Identification of the sensor or coil's valve section where the wire go to

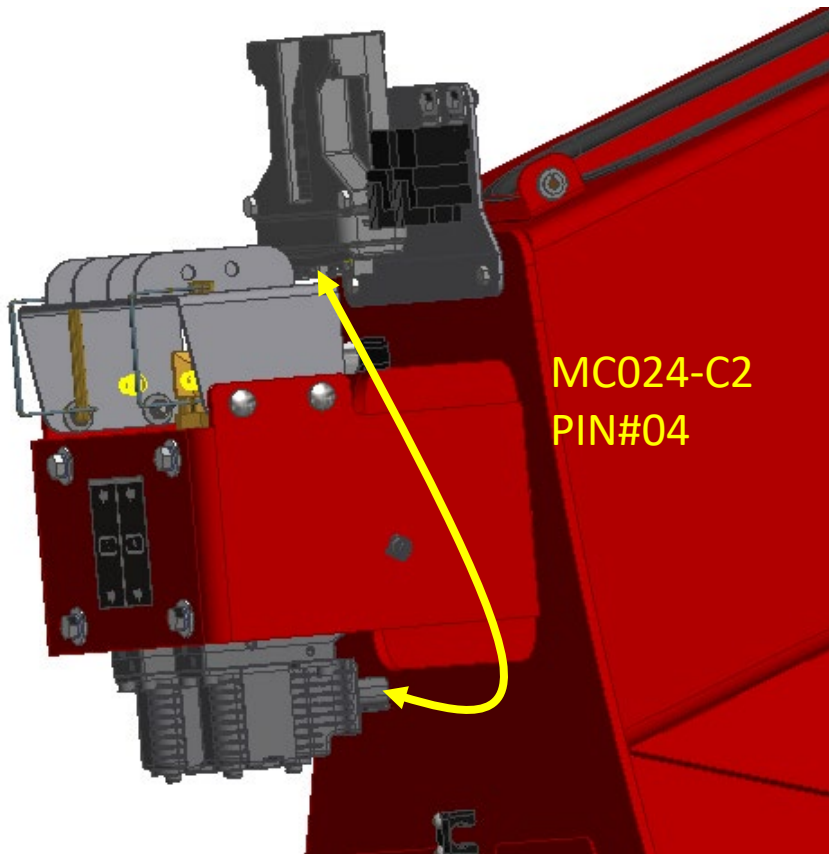
Error #10 means that you are experiencing a short-circuit between the controller and the solenoid valves of the “right conveyor”.

Inspect the wire from pin #04 of the MC024 controller’s C2 connector until solenoid valve “right” conveyor” located as below illustration. If the wire is damaged, replace of fix it.
