## Unstock extension/retraction arm (US-EUR model).

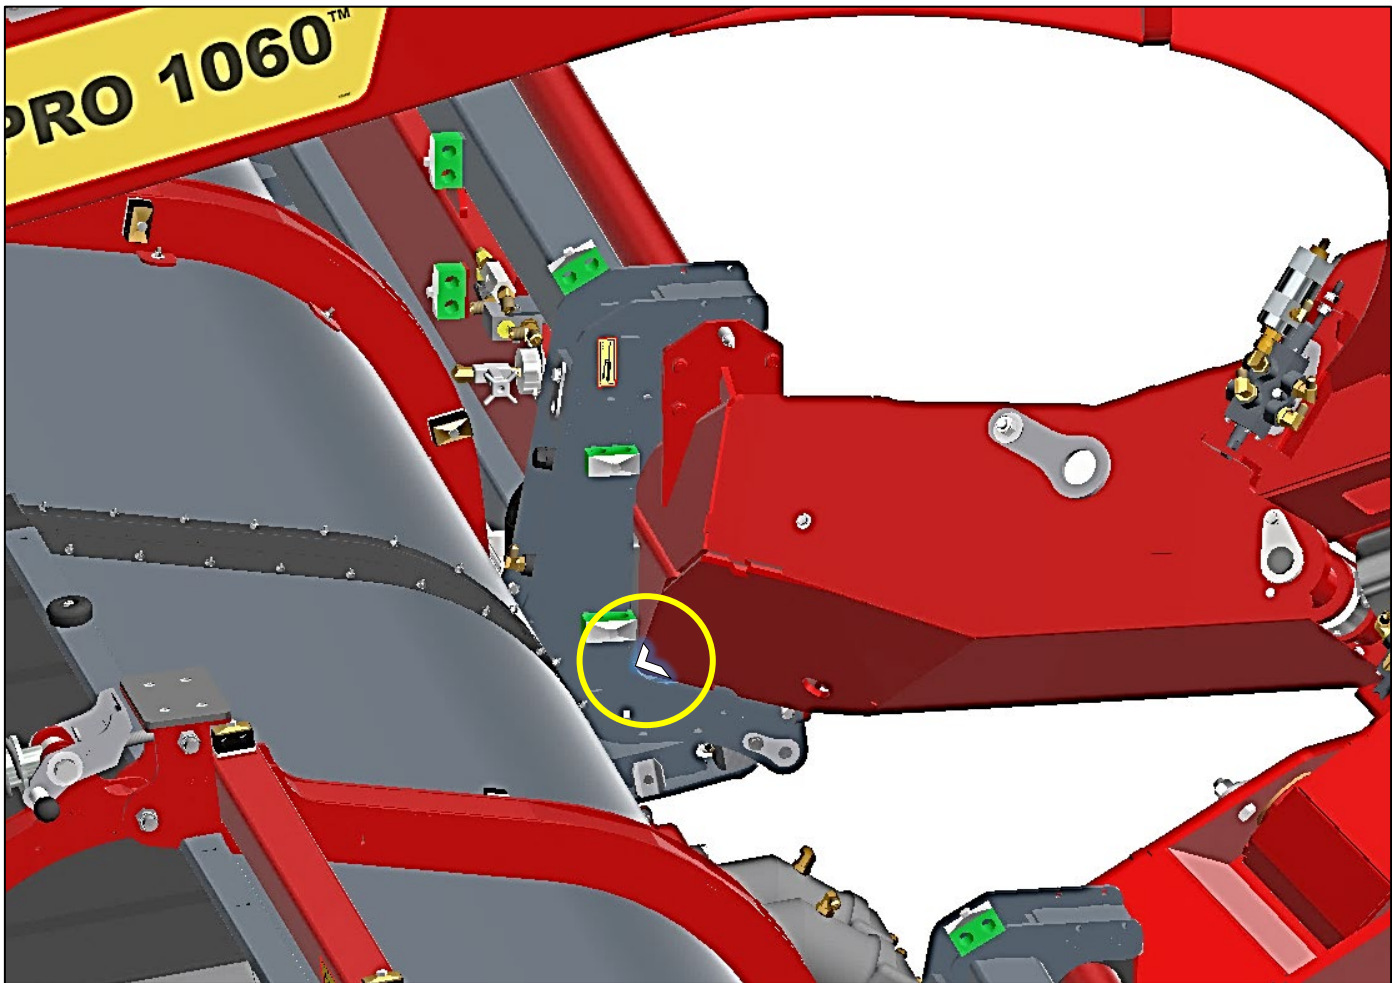
If, after a long storage or if the units have not been in extension mode during a long-time, you are experiencing a jamming while trying to move the arm, you must perform to disengage as following.

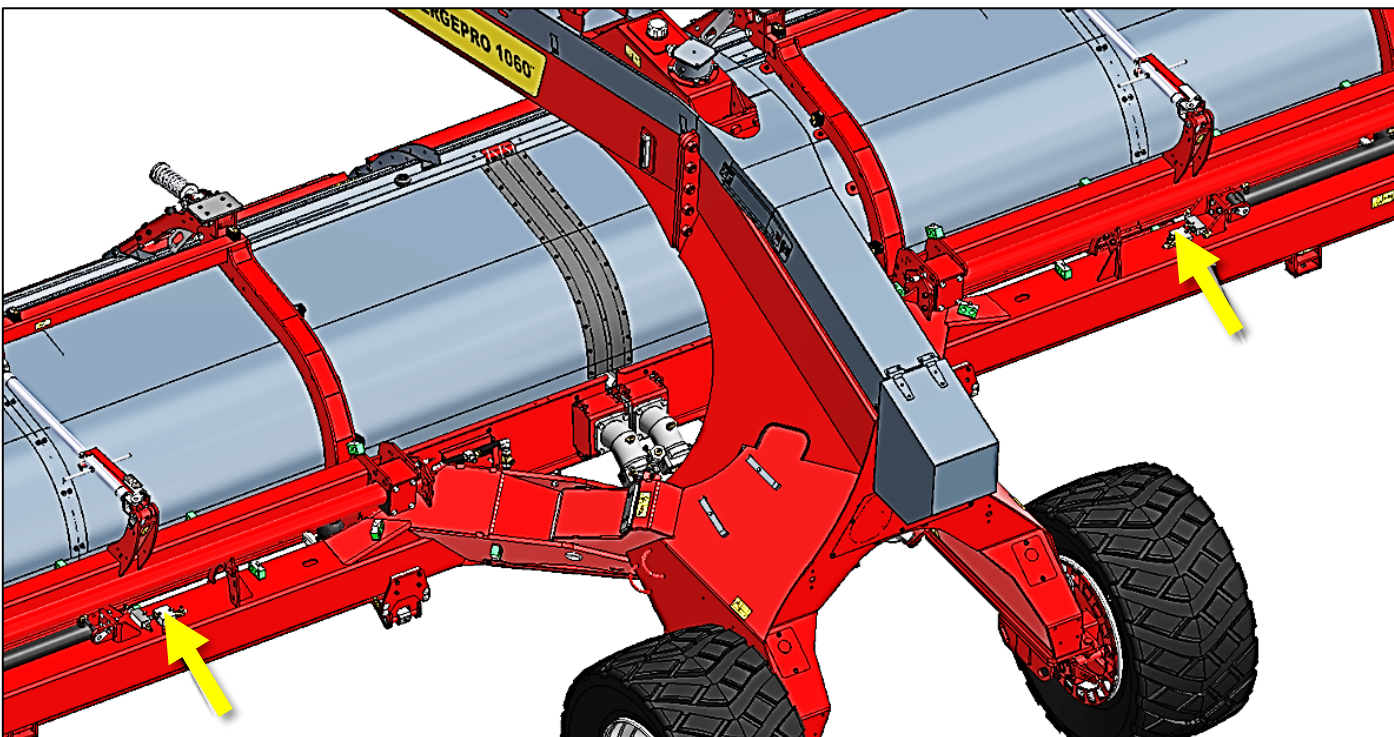
2. Locate the relief valves (below arrows) and screw them a few turns to increase the PSI to be able to move the unit.

3. With an angle grinder, sand the portion that was stuck to avoid this to happened again.
4. Screw back the 8 bolts of the Teflon blocs (unscrewed on step 1).
5. Place back the adjustment on the relief valves: Screw on completely the Allen screw then unscrew 5 turns.
